Physical Needs Assessment Inspection Report Kuhio Park Terrace

HCDCH# - HI0P001010

Honolulu, Oahu

Date of Inspection: 2/24/2003

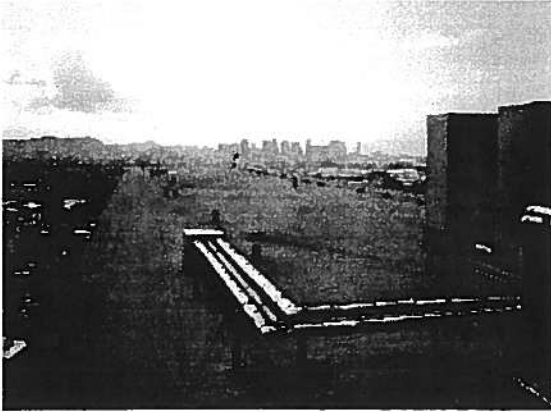
Roof

The roof is a built up material on all the buildings with deteriorated surfaces and ponding water conditions. The roof drains are not effective with plant life growing from the roof structure. In some areas the pitch pockets that support the solar collector panels are also deteriorated. Solar panel plumbing was also leaking on to the roof surfaces promoting the deterioration of the roof surfaces further. The roofs are in need of maintenance/repair and may require replacement prior to their expected useful life.
